SECTION I:

INTRODUCTION

PROTECTIVE GLAZING STUDY BACKGROUND

PROTECTIVE GLAZING PROJECT SCOPE

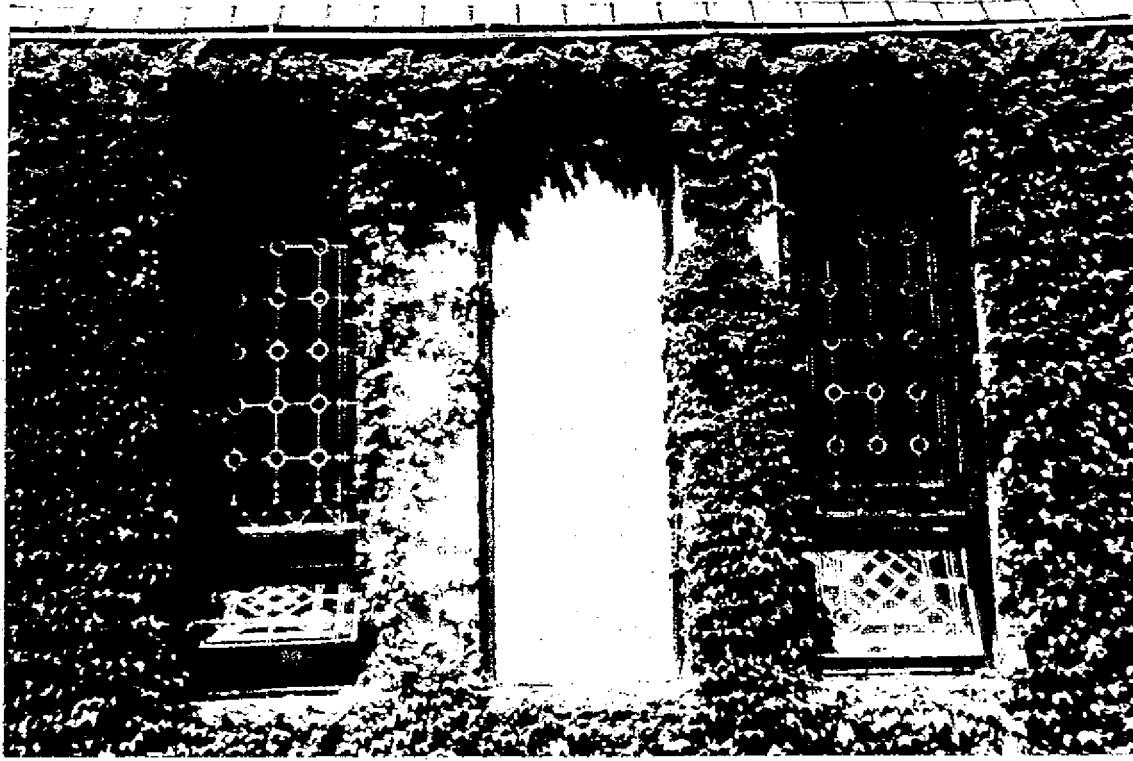
Fig 1. Most of the windows were tested in direct sunlight.

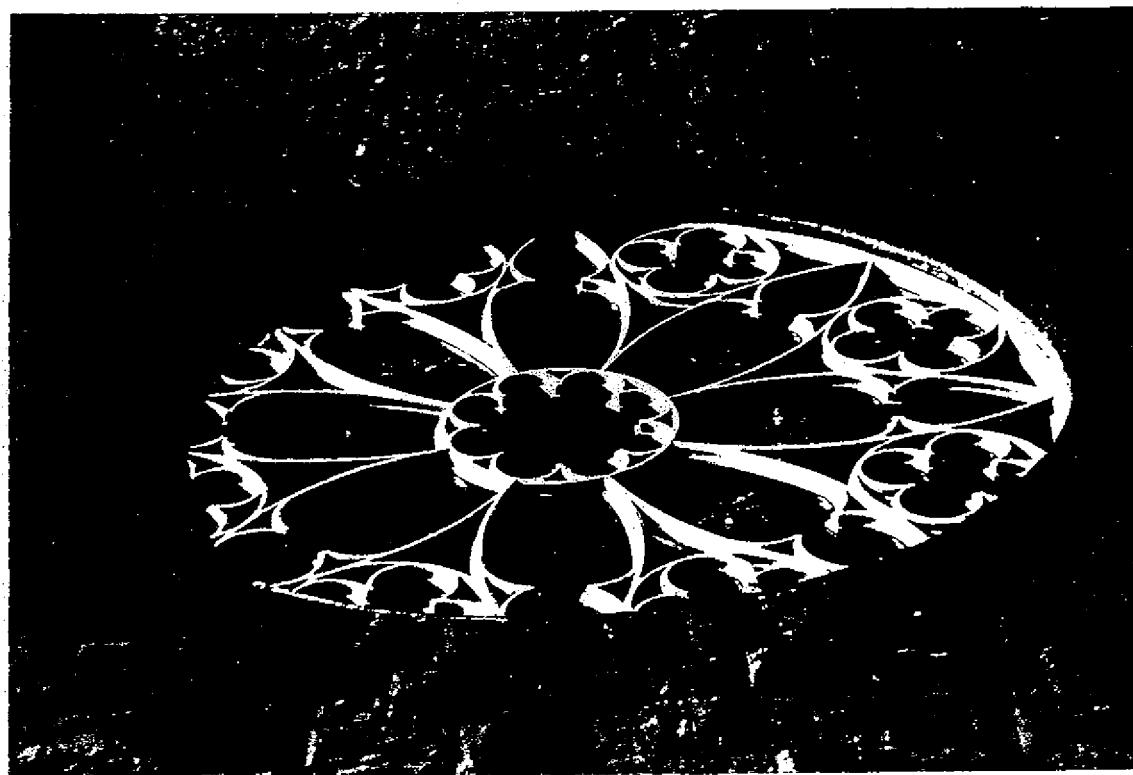
Fig 2. Approximately 60% of the windows surveyed had intricate tracery.

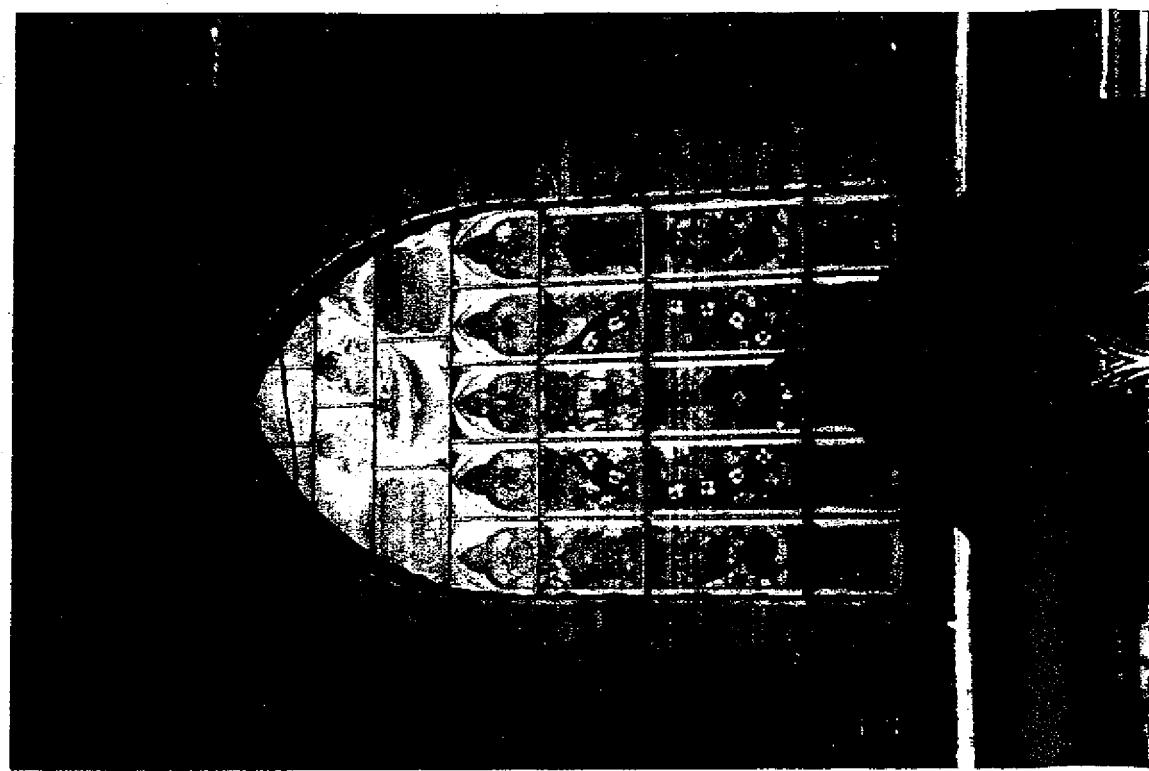
Fig 3. Security was not an issue for most of the windows.

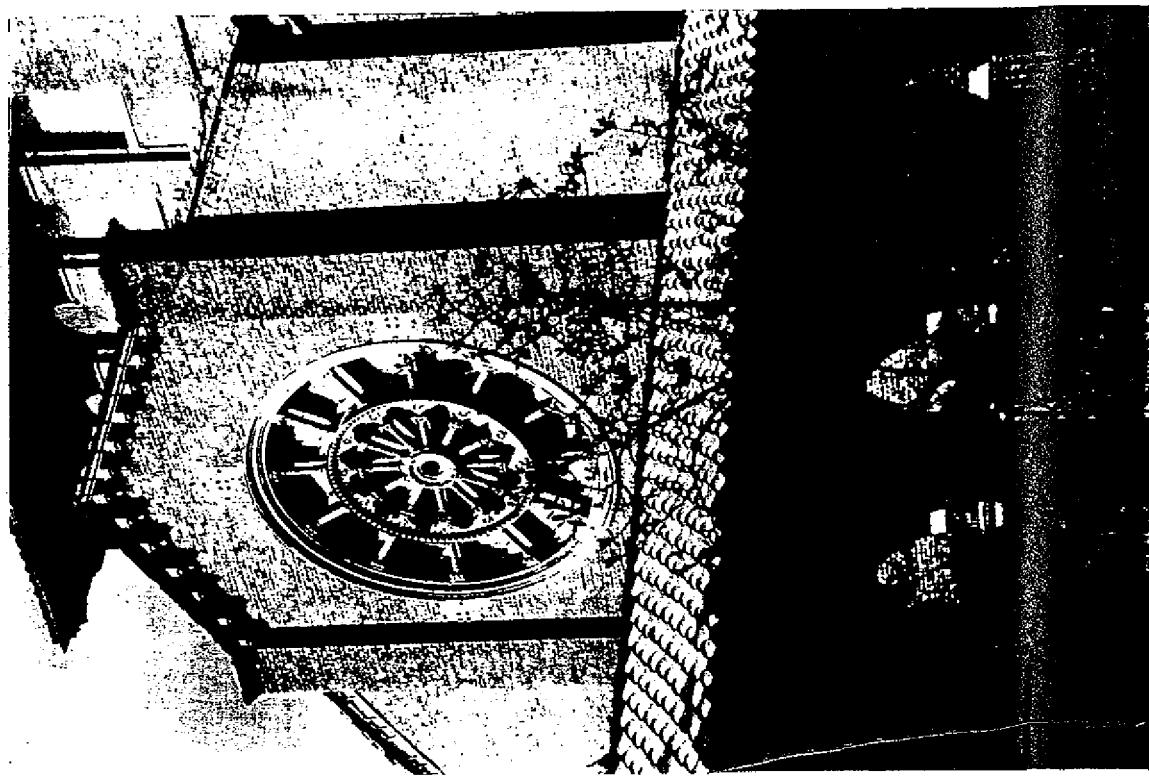
Ironically, although response to the questionnaire signify that most studios vent their PG installations, only 4% of those surveyed in the field were intentionally vented [FIG 5.]. Another 19 have self-vented over time due to deteriorated sealants or broken glazing [FIG 6.]. The depth of the air space varies greatly and is usually contingent upon the window frame and ease of installation, over 75% are set more than 1" from the stained glass. Condensation is unquestionably a problem with PG installations as evidence of condensation was found in nearly 70% of the windows; while 10% of the windows were too obscured to see at all. As expected, the Southwest installations, that are located in regions where the average relative humidity is below 20%, generally had little or no evidence of condensation. Glass temperatures, measured in direct sunlight were always higher than ambient indoor or outdoor temperatures, averaging between 18°F and 21°F higher. The temperatures varied depending on the color of the glass, wind speed, and how long the window had been exposed to direct sunlight at the time of testing.

Fig 5. Only 4% of the PG surveyed was intentionally vented.

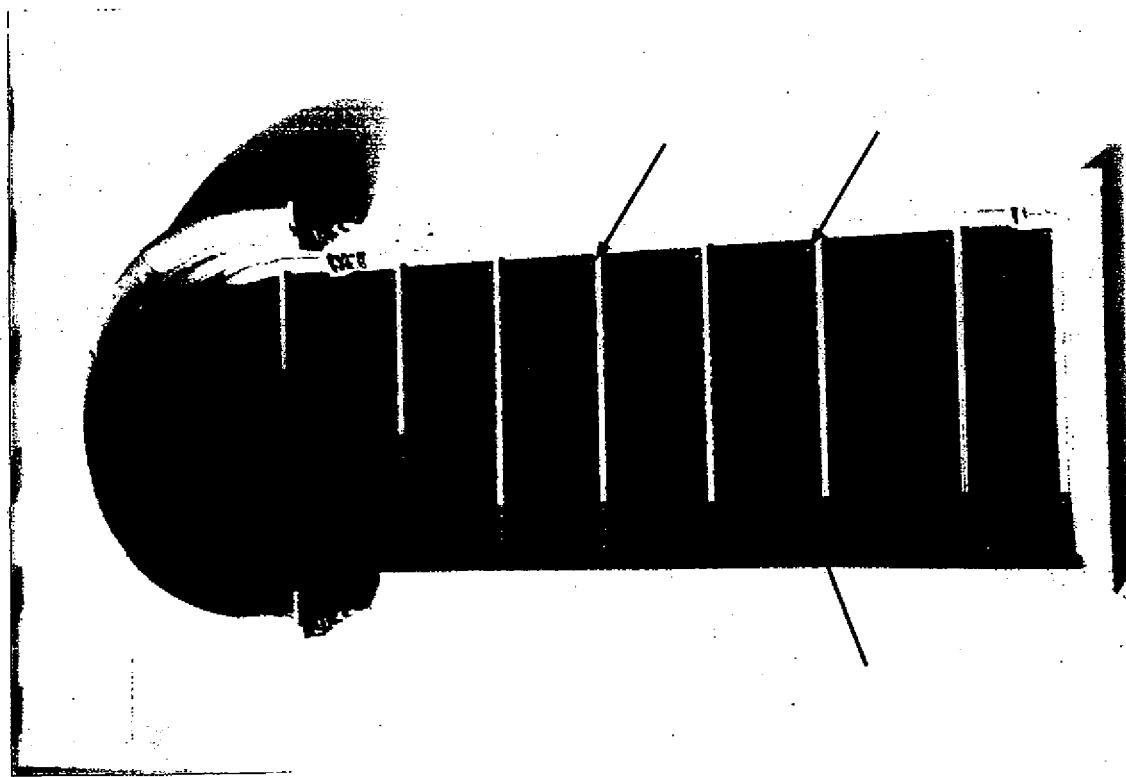
Fig 6. Many windows have self-vented as sealants breakdown.

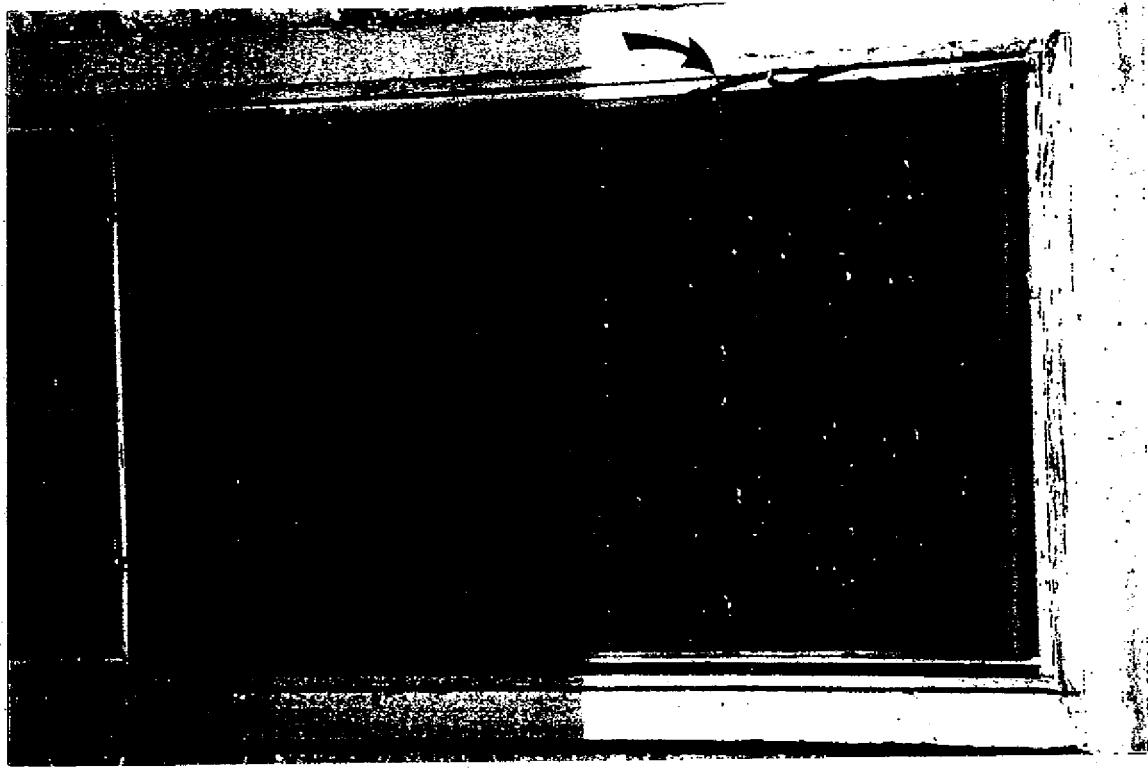
Fig 7. Glazing sealants and frames often deteriorate behind PG.

Nevertheless, the waterproofing (cement) was missing in areas on 40% of the windows and had completely failed on another 22% -- regardless of their quality. Moreover, the perimeter sealants had partially or totally failed on half of the PG installations. The PG definitely prevents proper window maintenance; approximately one-third of the windows surveyed required maintenance to the metal or wood frames, which were not accessible due to the PG [FIG 7.].

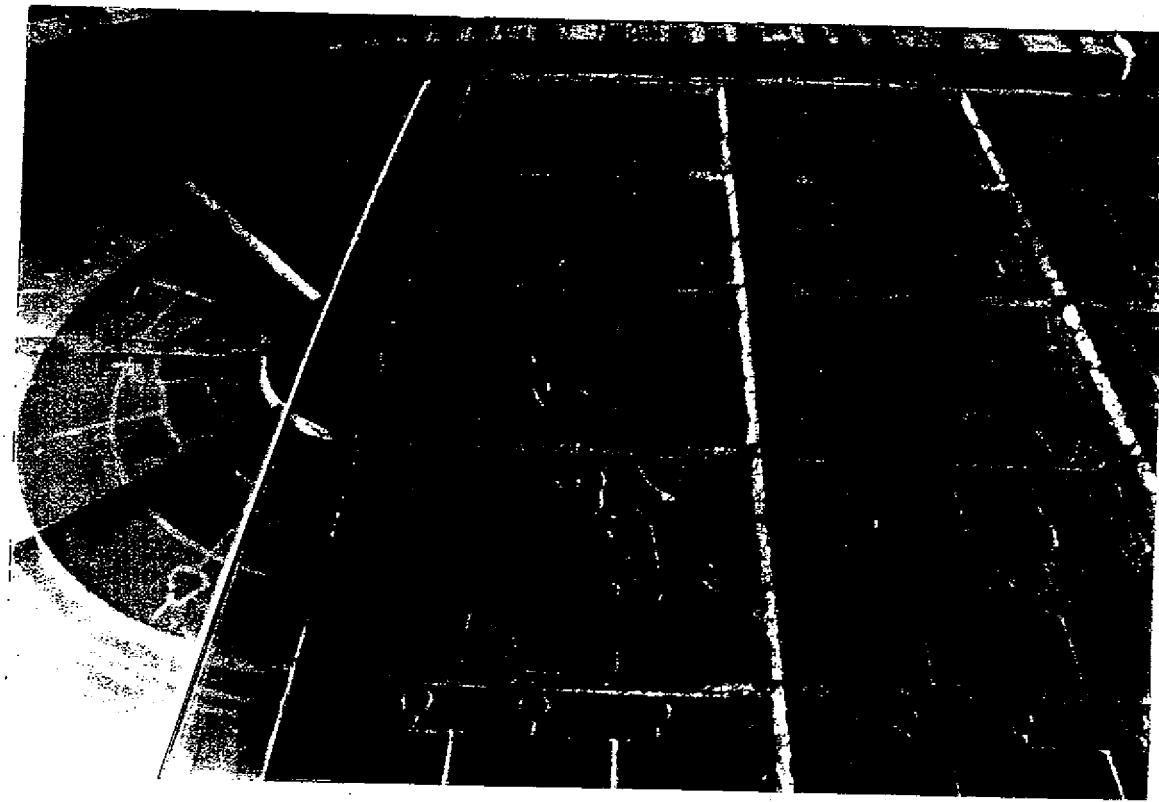
Fig 8. PG can be integrated with the original tracery.

Charleston, SC, and Savannah, GA were selected for their concentration of historic churches, strong preservation movement, good church documentation, and vulnerability to hurricanes. Surprisingly, several of the churches without PG suffered no stained glass damage from Hurricane Hugo in 1989. Other windows covered with PG actually had the entire window (frame and all) blown out of the window opening. Exposed stained glass is very resistant to wind pressure, but is vulnerable to flying objects. The vast majority of stained glass damage resulting from Hurricane Hugo was caused by flying roofing and siding materials, branches or debris hurled into the windows as opposed to wind or rain from the storm itself. All but one of the Southeast churches were air conditioned, and most of air conditioning systems were on during the field survey. Combined with high relative humidity, which averaged between 50% and 60%, the air conditioned interiors were causing the worst condensation problems observed anywhere. Congregations located in strong preservation communities like Charleston and Savannah, tend to integrate PG more carefully within the original window frame and tracery [FIG 8.]
